**Asnuntuck Community College  
Welding Shop Room 138  
Gas Odor Investigation Assistance**

**170 Elm Street  
Enfield, CT 06082**

~~December 12, 2022~~  
Revised January 4, 2023  
van Zelm Project #: 2022216.00

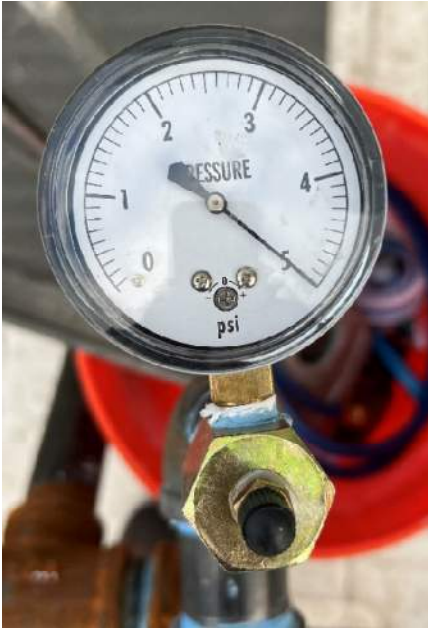
**Start**

The test pressure started at 5 PSI but then dipped to about 4.5 PSI as the nitrogen air mixture acclimated to the piping temperature. As the sun came out and the piping warmed, the pressure then rose above the maximum gage reading of 5 PSI which we estimated as about 6 PSI.

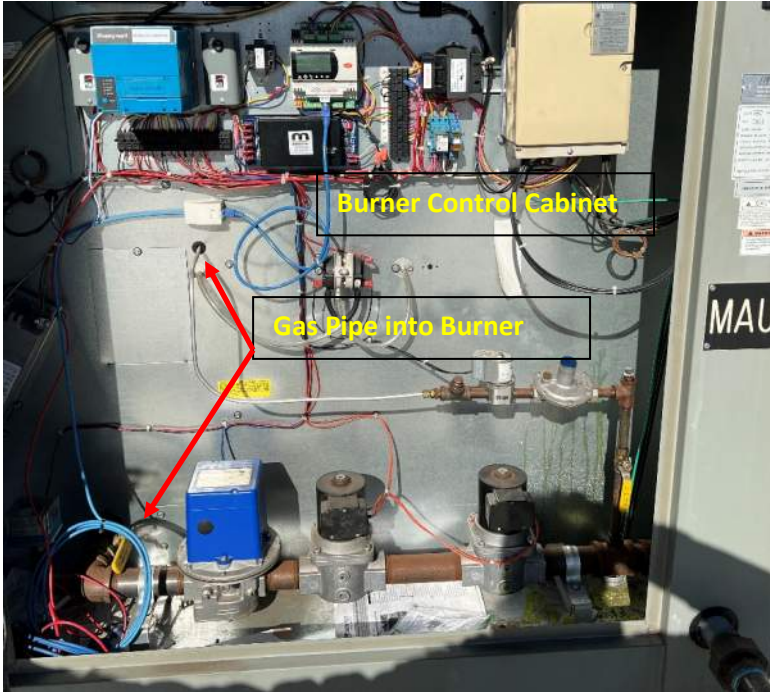
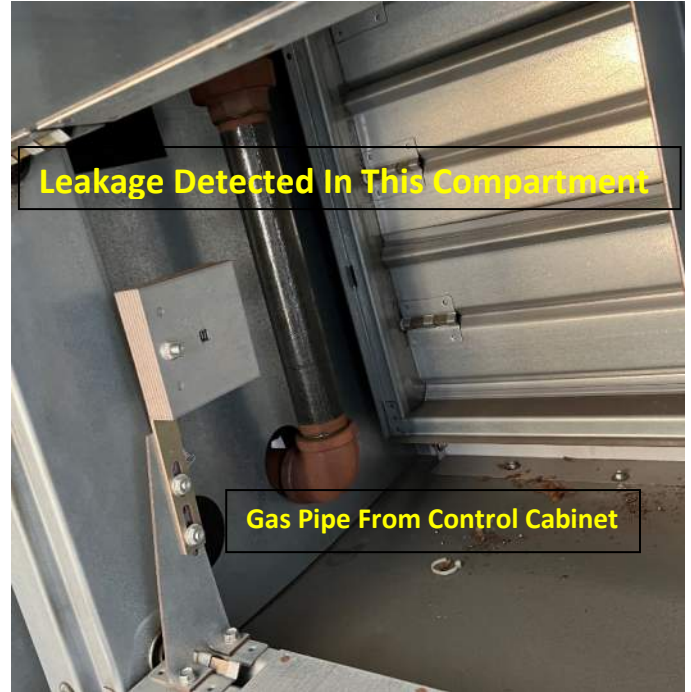
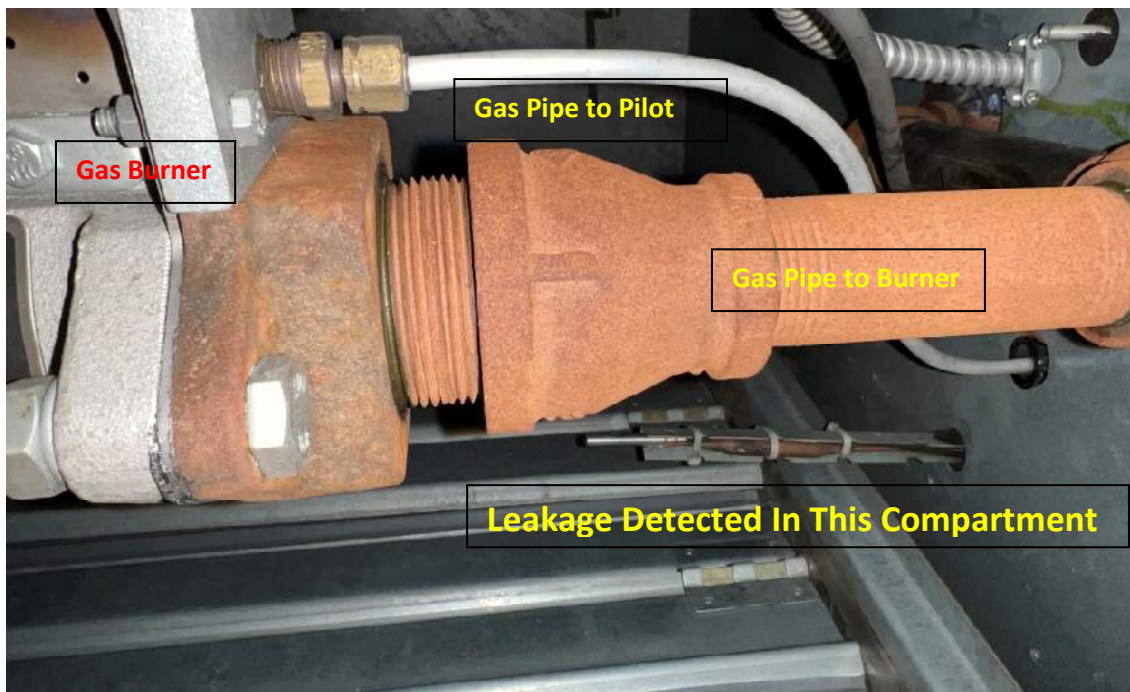
On Saturday, December 10, 2022, while evaluating the operation of the units, van Zelm used the handheld gas detection meter provided by the college and found signs of gas leakage on the inside of the units near the burners. MUA 1 seemed to have more leakage than MUA 2.

With the unit operating, we detected levels of gas at the inlet of the burner and around the portion of the gas pipe that is not visible from the piping of the gas train. We attempted to test this piping on Friday with the soap solution but with the unit operating, the solution would not adhere to the pipe fittings due to the airflow within the unit.

**Typical locations where gas leakage was detected inside the unit**

**This piping can only be checked with the burner firing**

Our recommendation is to develop a method and further leak check the small amount of piping near the burner. If the joints are not able to be tested removing the burner assembly, refitting it and reinstalling it may be necessary. Once this has been done the airstream can be checked for gas again.
