SEWER LINE INVESTIGATION

Asnuntuck Community College

MAY 4, 2023

Project No. BI-CTC-651

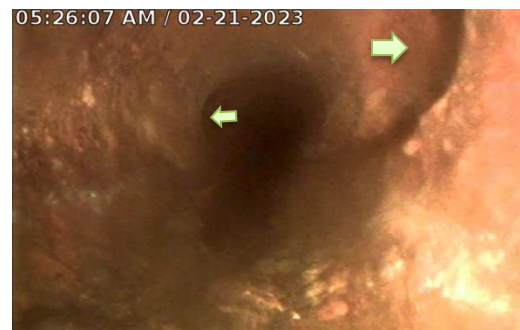
1. The clip starts with inserting the camera into the system and through the cleanout companion flange that closes off the piping while not in use. Once in the pipe, the initial view shows the apparent women's bathroom sink connection on the right and the janitor closet just beyond on the left (2'0" - 0:50 sec)

Green arrows represent inlets into line.
(disregard time shown on camera)

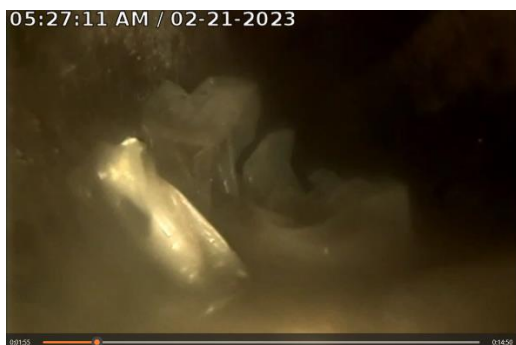
4. From approximately 12' to 38' the sewage is again above the camera lens.
5. At approximately 38'9" (1:28 sec.) the camera again enters free flowing pipe. The technician felt the camera pass through the two 45° bends shown on the plumbing design. There is additional evidence of toilet paper in the piping again potentially restricting the free flow of sewage from 12' to 38'.

Toilet paper evident at 38'.

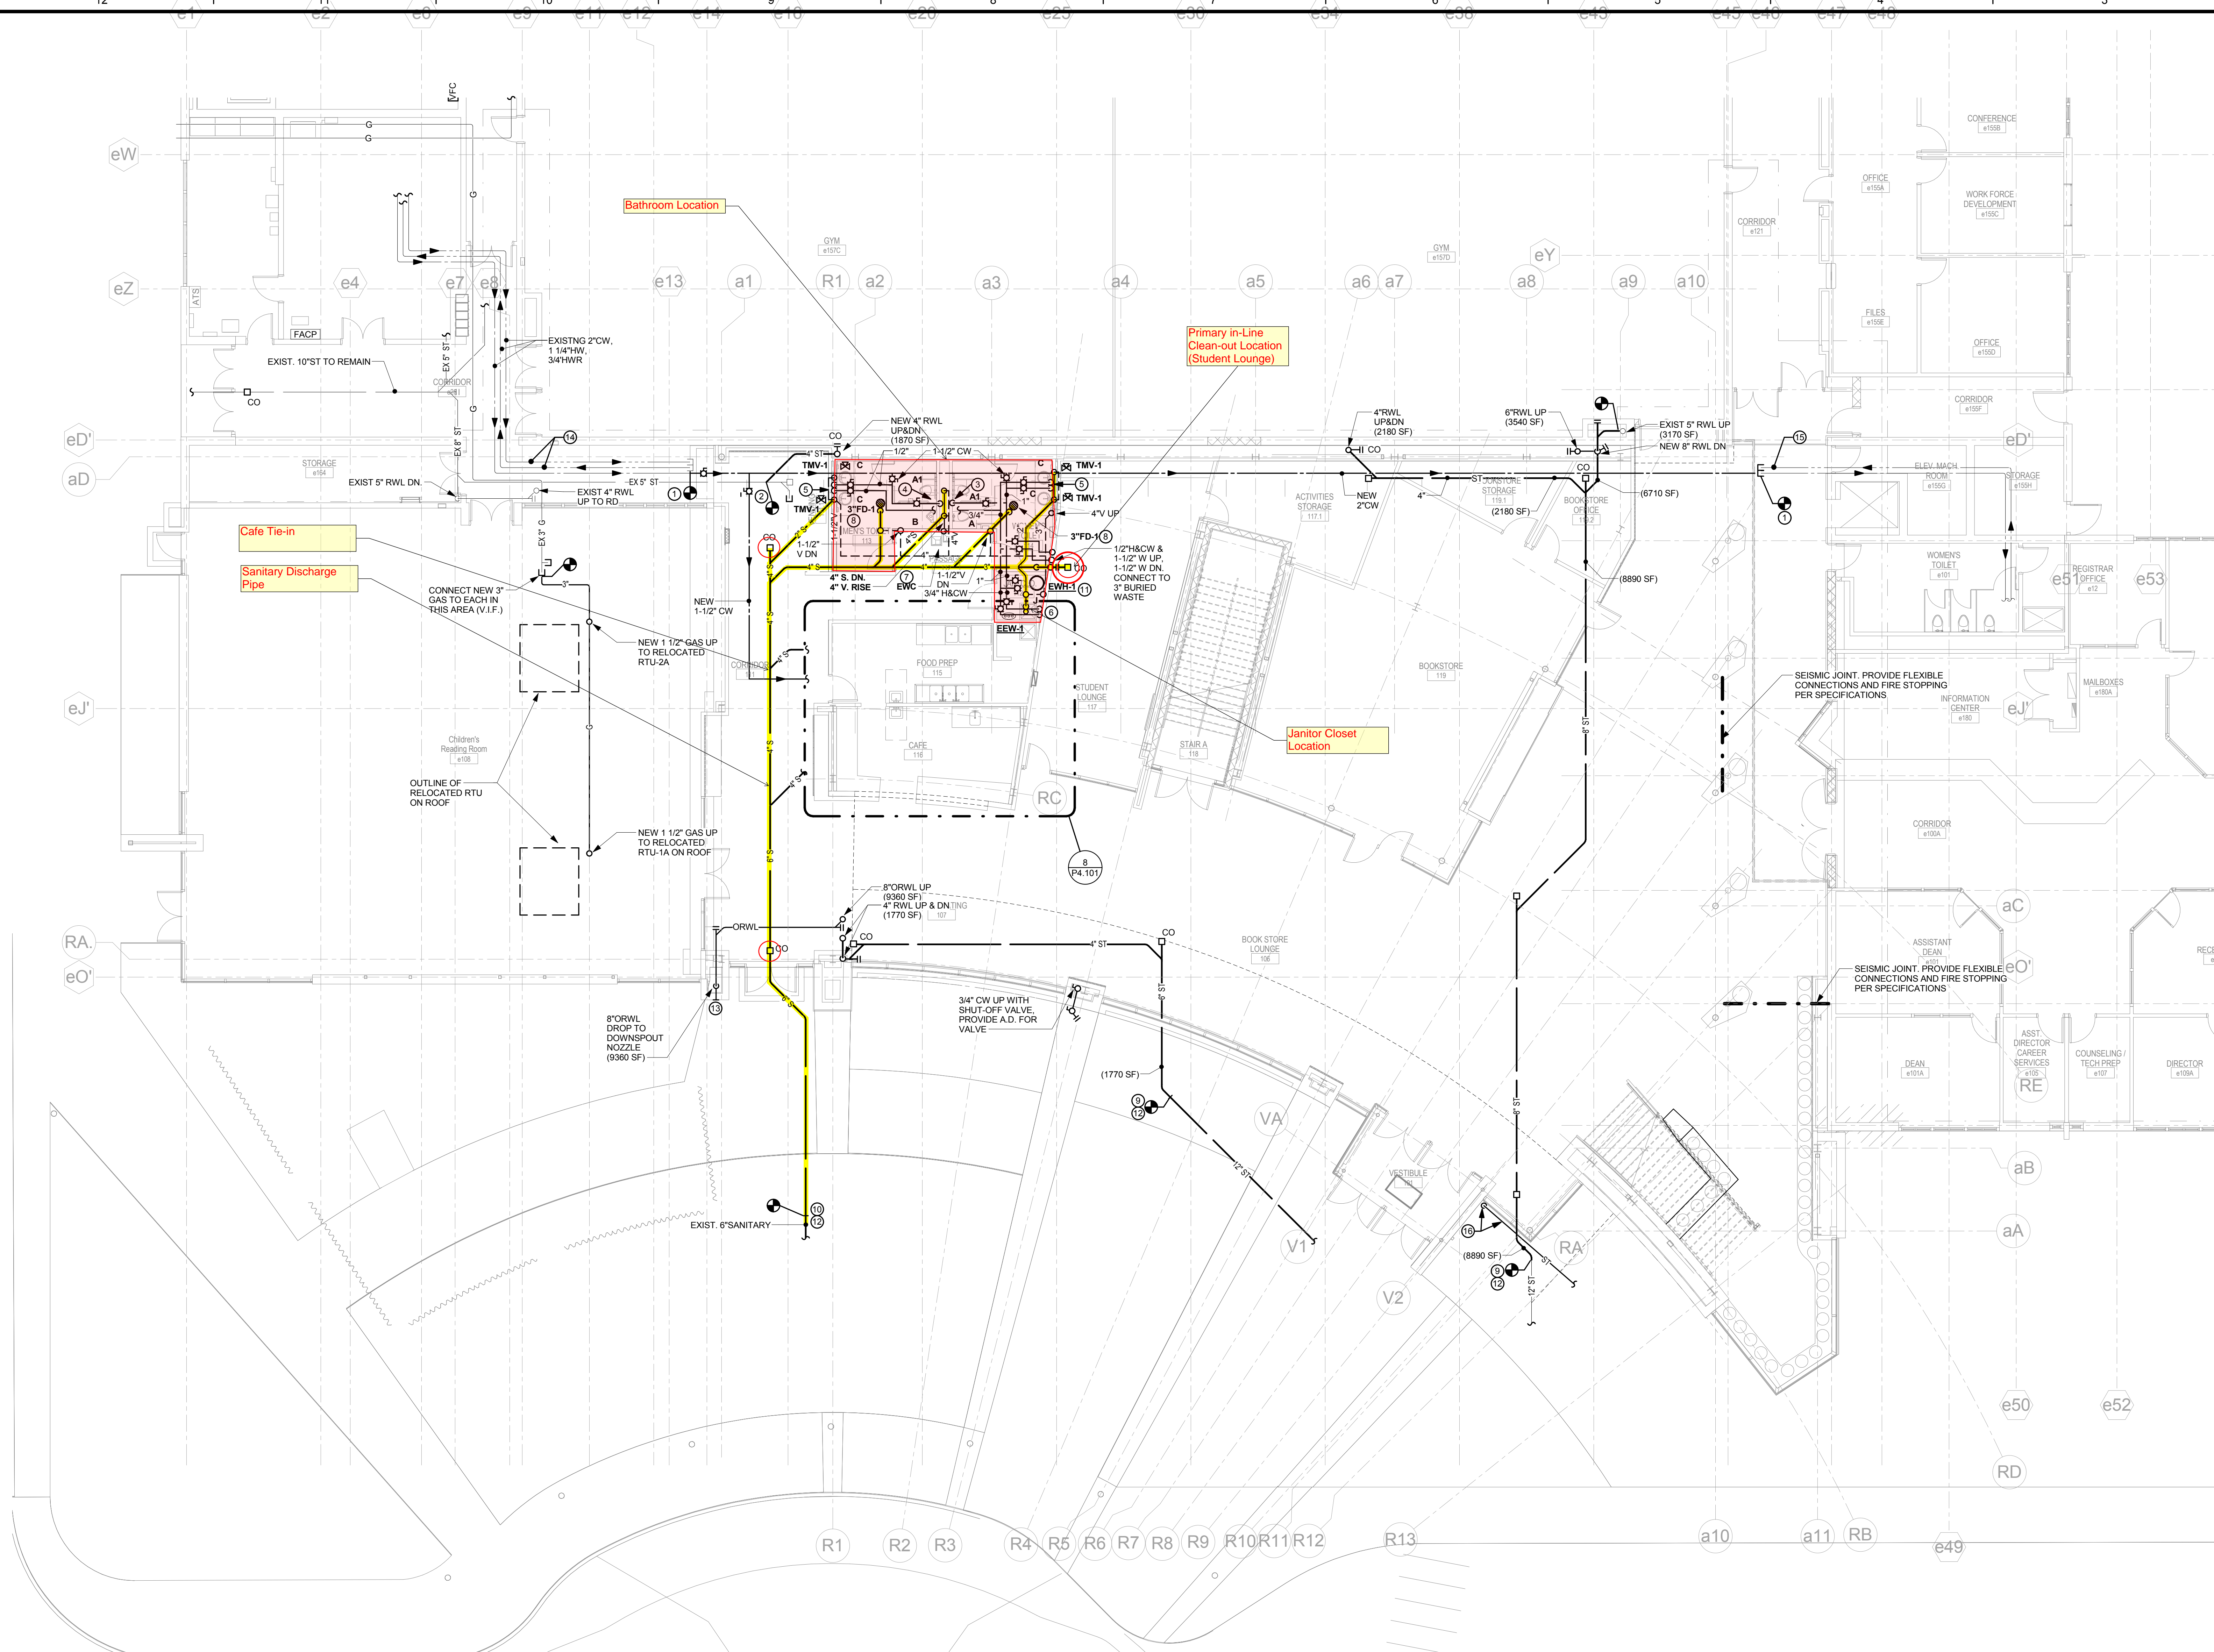
Plan Sheet P2.201

Prior to the meeting, DAS provided to BSC the bid set for the Campus Renovations Project No. BI-CTC-437 for the renovations at ACC construction after 2015 at the campus. BSC reviewed the document and determined that Sheet No. P2.201 identifies a 4" sanitary discharge pipe running east by a set of bathrooms on the ground floor. From these bathrooms, the sanitary discharge pipe turns north in a main hallway, passing a café, before upsizing to a 6" pipe and exiting the building.

Please find Sheet P2.201 attached as Appendix A with the sanitary discharge pipe highlighted for clarity.

Prior to the investigation, BSC identified three (3) potential cleanout locations in the floor slab as potential entrance points for the CCTV. The cleanout locations are identified in Appendix A by red circles.

cleanout is located at the farthest point away from the discharge from the building and will allow the camera to pass all relevant connections that flooded in the past, including the floor sink in the janitor's closet, the women's bathroom toilets and floor drain, the men's bathroom toilets and floor drain, the 90-degree bend to the north, and the discharge to the sewer manhole located within the front plaza. The primary in-line cleanout is identified on Appendix A with a double red circle.
