**Asnuntuck Community College  
Welding Shop Room 138  
Gas Odor Investigation Assistance**

**170 Elm Street  
Enfield, CT 06082**

~~December 12, 2022~~  
Revised January 4, 2023  
van Zelm Project #: 2022216.00

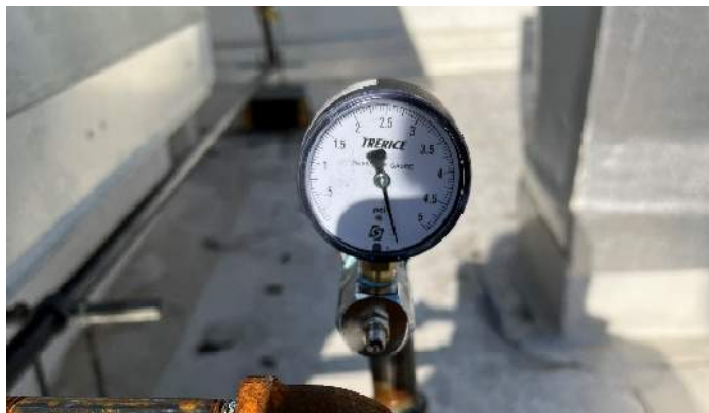
No gas leaks were detected during the requested gas pressure testing process. However, once the units were turned back on, leakage was detected with the handheld gas detection meter inside the units near the burners. This will need to be corrected before placing the units back into service.

**Typical locations where gas leakage was detected inside the unit**
